DCMC innovation track 5: Developing automated repair techniques for repair of composite structures

Project progress

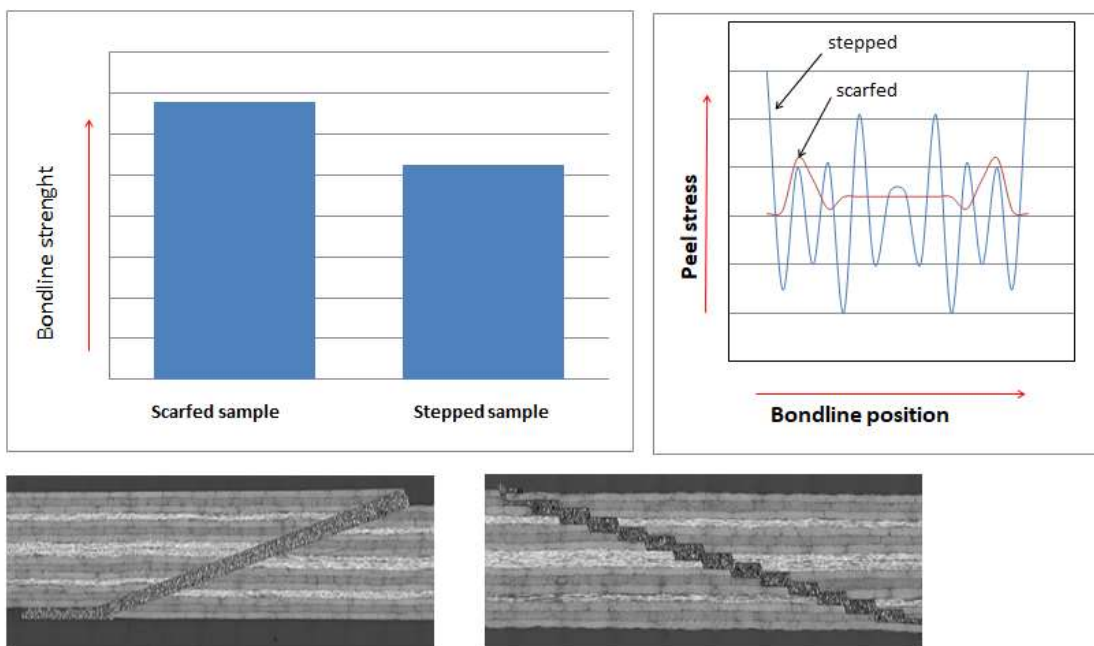
Small sized 2mm thick epoxy/carbon tensile samples were manufacture and adhesive bonded. The bonded surface was prepared using a number of milling/sanding strategies. As an example the stepped and scarfed prepared samples are displayed in the figure below.

The micro sections show clearly the difference between the two samples. The peel stresses are calculated by using the NLR developed Excel based BondedJoint® software. Due to the high peel stresses for the stepped surface the resulting strength is lower compared to the scarfed surface.

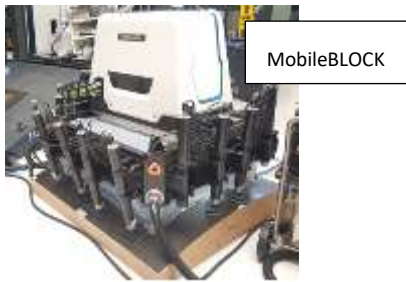
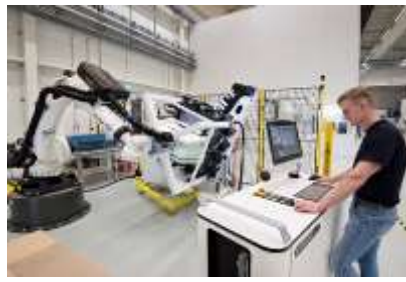
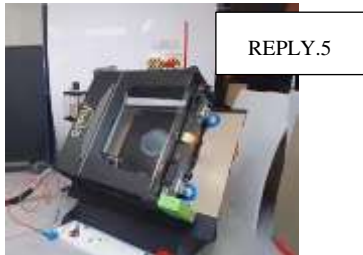
The MobileBlock (MB) milling robot that was demonstrated can only be used for large airframe surfaces. Application on smaller and complex shaped surfaces (like the NH90 tail) is not possible. Also the large weight and size makes it difficult for positioning on aircraft structures. The MB was coupled to the NLR robot and positioned on a NH90 tail section and a 787 elevator (see pictures below).

A promising abrasion method that was demonstrated in this project is the light weighted water jet machine developed by the French company Bayab, this machine can easily be positioned over the damaged area by the operator. Also for this machine it is not possible to use it on smaller and complex shaped surfaces.

MobileBLOCK and REPLY.5 positioned on sample panels and MobileBLOCK positioned on the NH90 tail and 787 elevator.

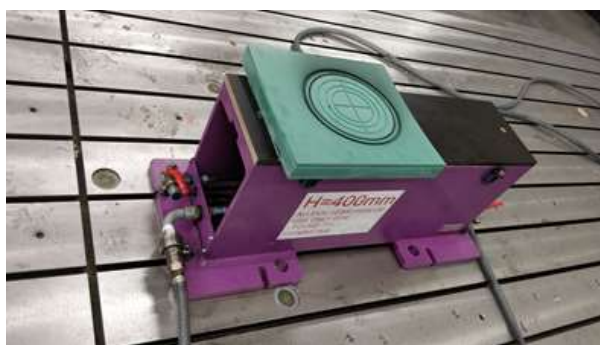
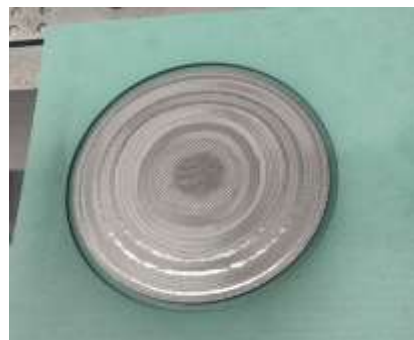
The patch was milled from a second composite panel with the same lay-up as the demonstrator panel, the generated milling file was used for CNC milling of the bonding surface.

Patch milling fixation tool and milled patch.
